Charfield STW Case Study: Inlet Screen Replacement Project

As part of the Wessex Water inlet screen replacement projects, HUBER Technology completed the delivery and installation of a new inlet screen and screenings handling project at Charfield STW near Wooton under Edge.

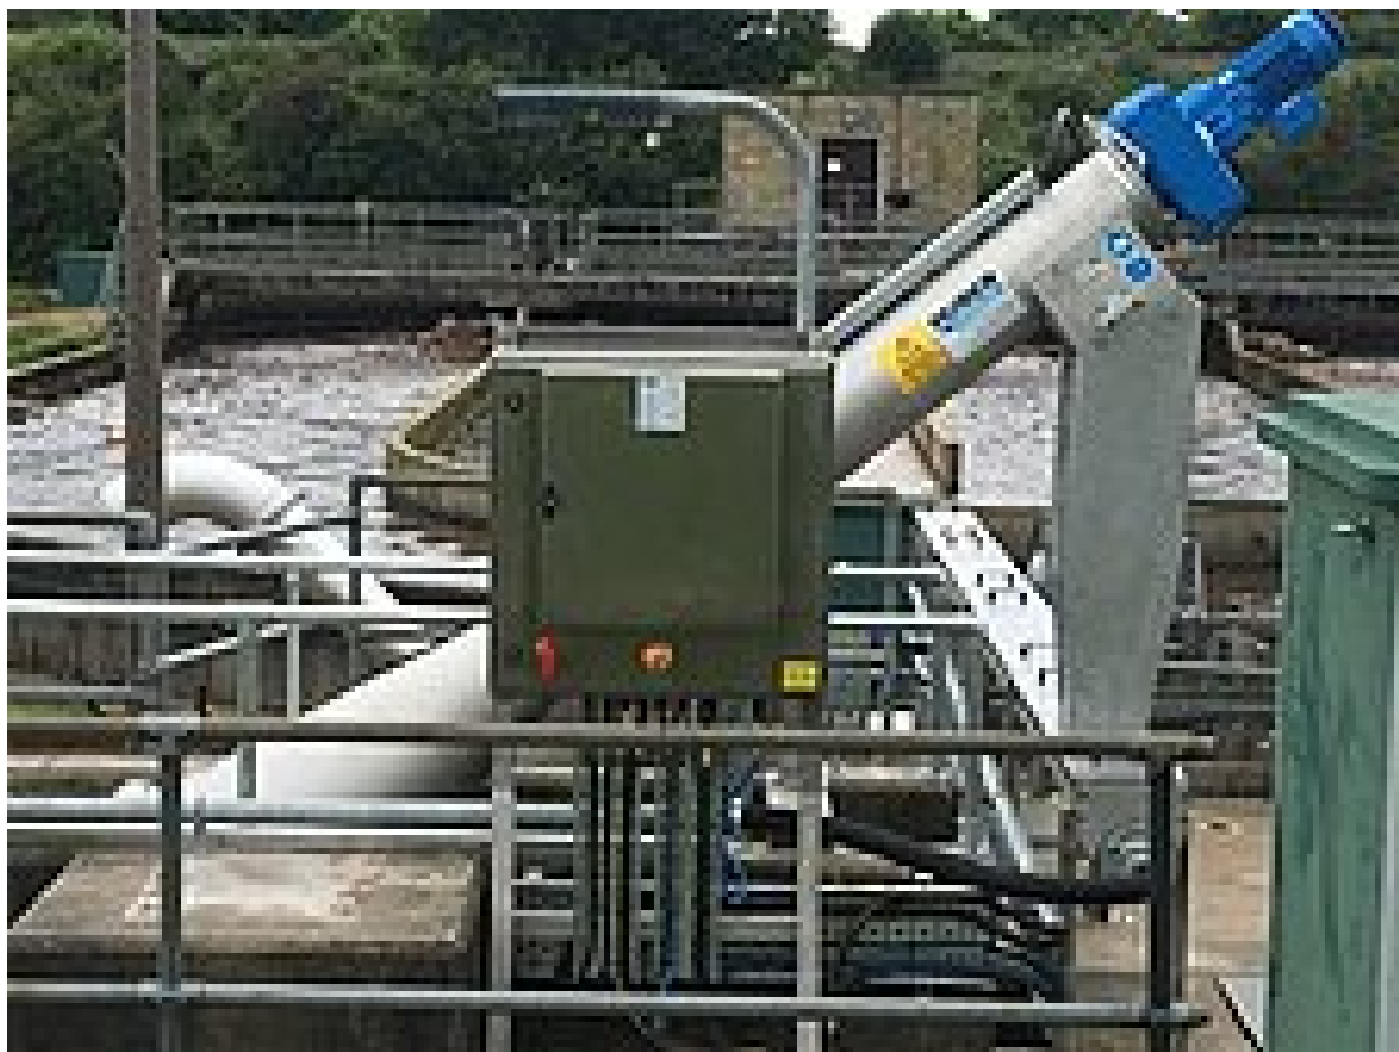
HUBER Micro Strainer ROTAMAT® Ro9 installed at Charfield STW

We modified our combined screen (HUBER Micro Strainer ROTAMAT® Ro9) so that it ran without washwater and no compaction, it was essentially a conveyor to elevate the screens into a small washpactor (Washpress WAP®/L). This Inlet screen was one of the first Ro9's without the washwater feature to be supplied into the UK for the Wessex Water inlet screen replacement projects. This innovative idea of discharging from the Ro9 into a launder was a success and is currently working extremely well.

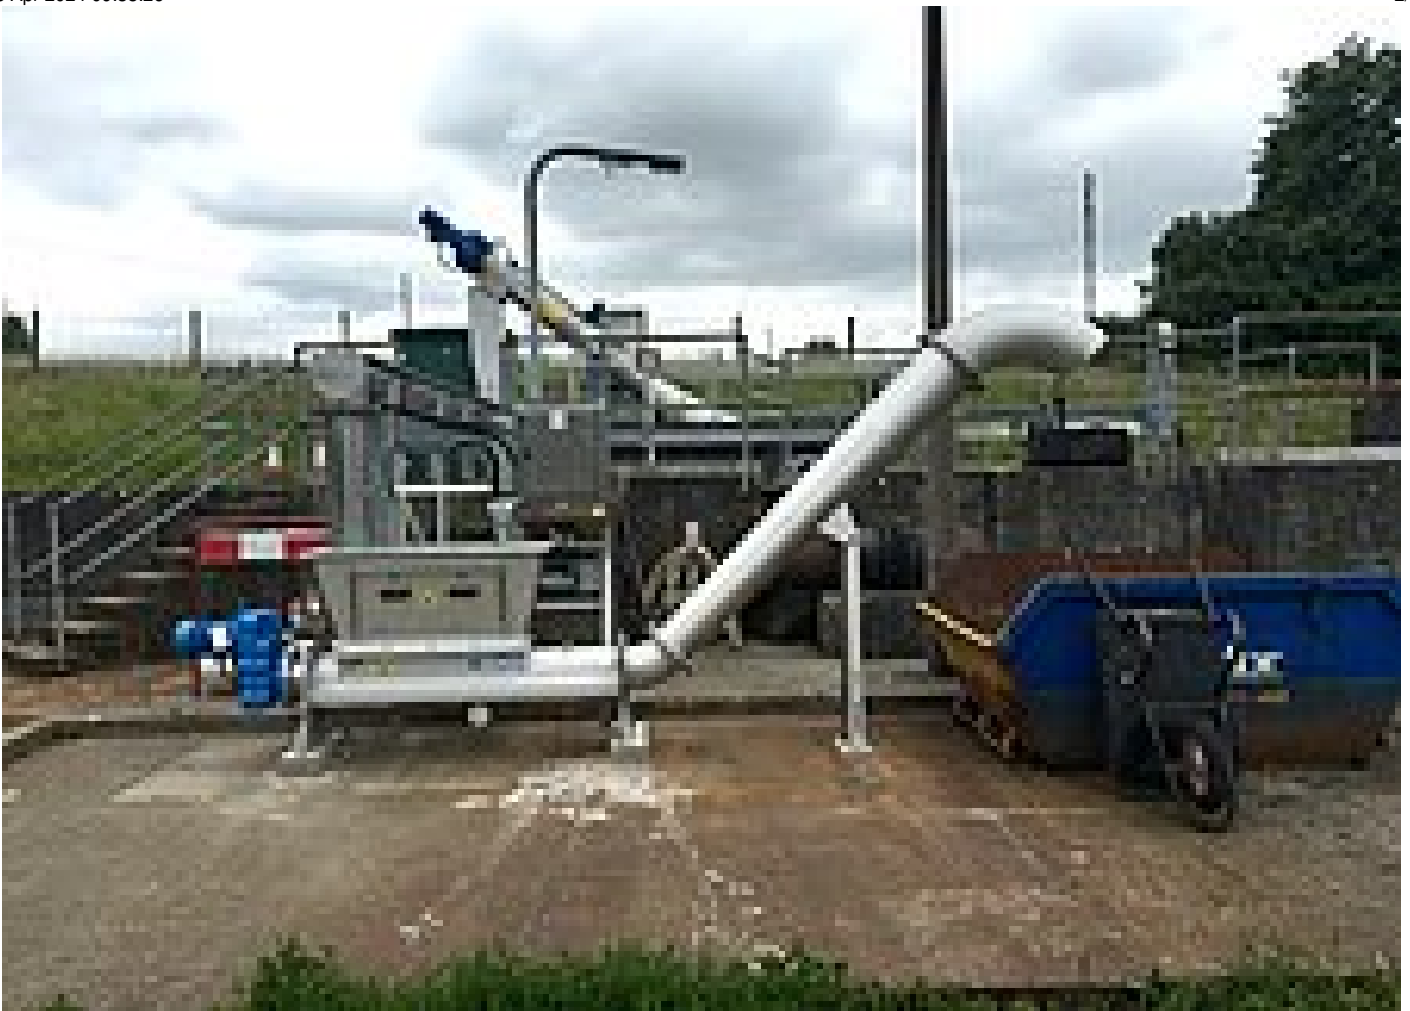
The complete HUBER installation with Wash Press WAP®/L in the foreground

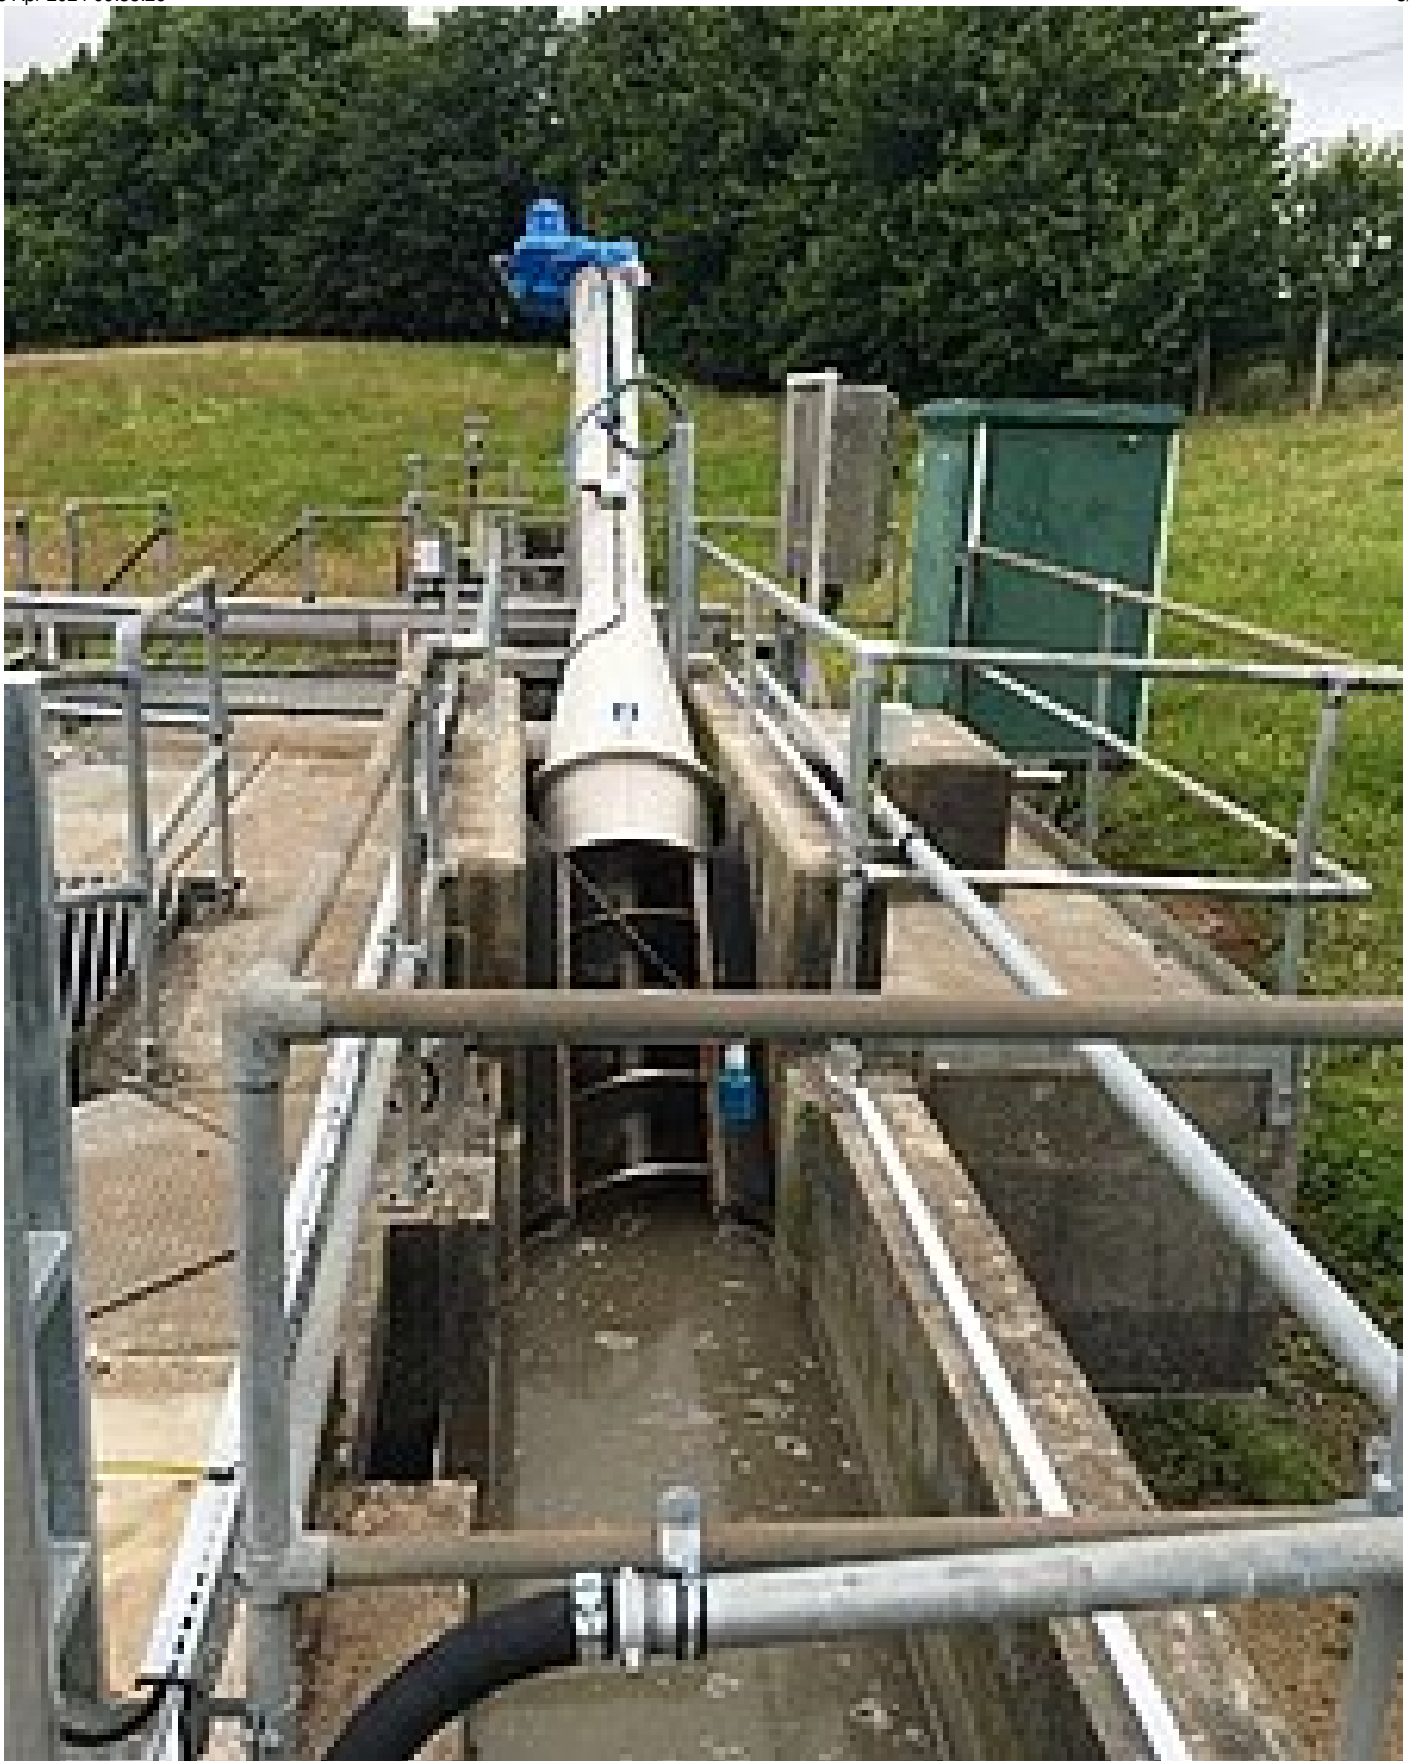
The modified HUBER Micro Strainer ROTAMAT® Ro9 in the inlet screen channel

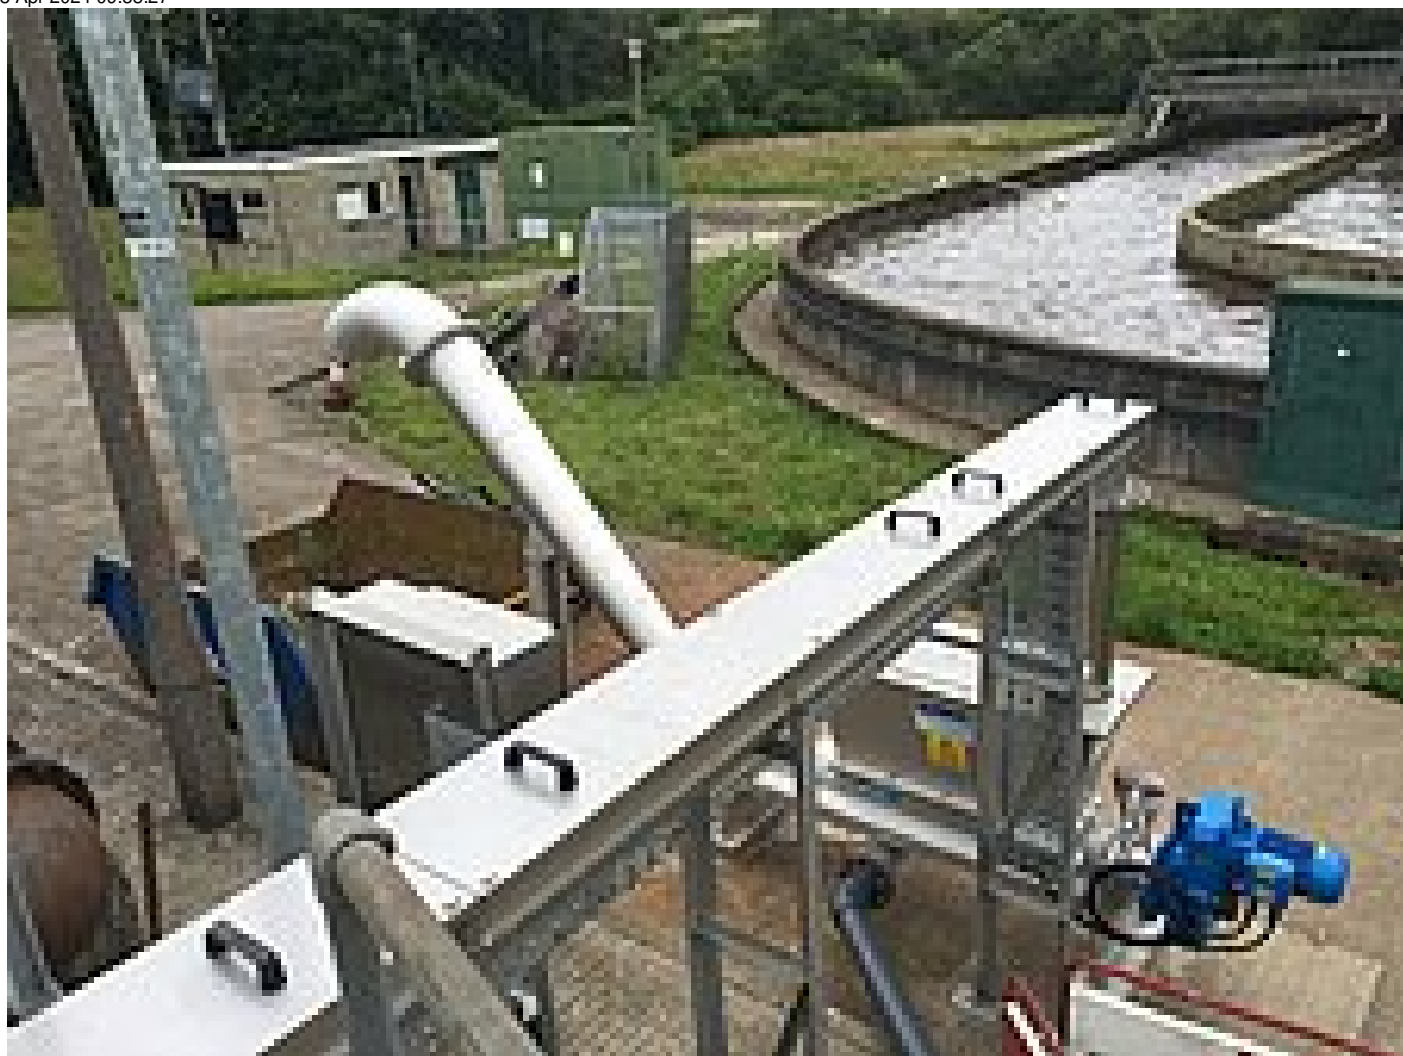
Launder Channel feeding the Wash Press

The lack of washwater for the launder resulted in an additional modification - Wessex Water fitting a submersible pump in a chamber upfront of the screen, this chamber had a 6mm perforated plate upfront to prevent large rag blocking the pump. The pump starter was included in our control panel and was linked to the screen start.

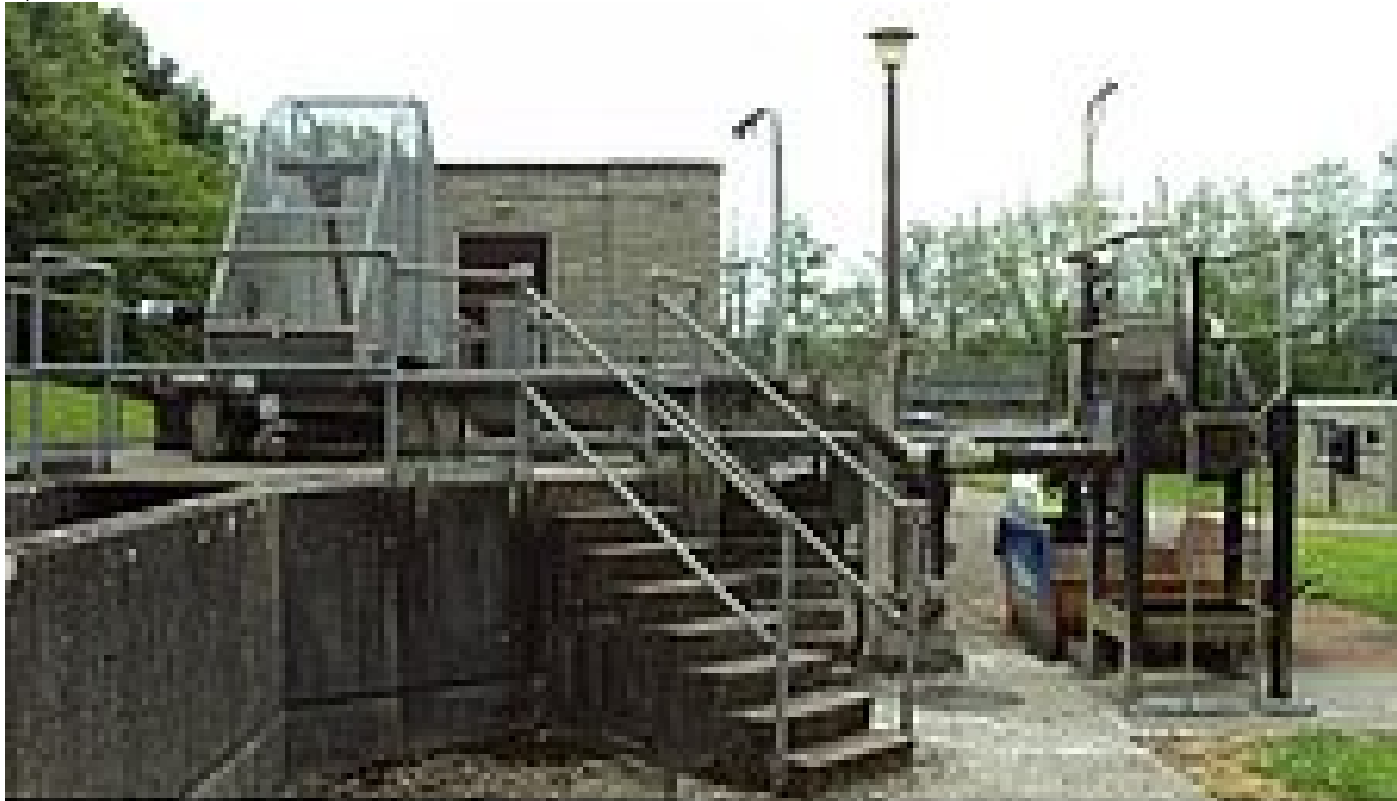
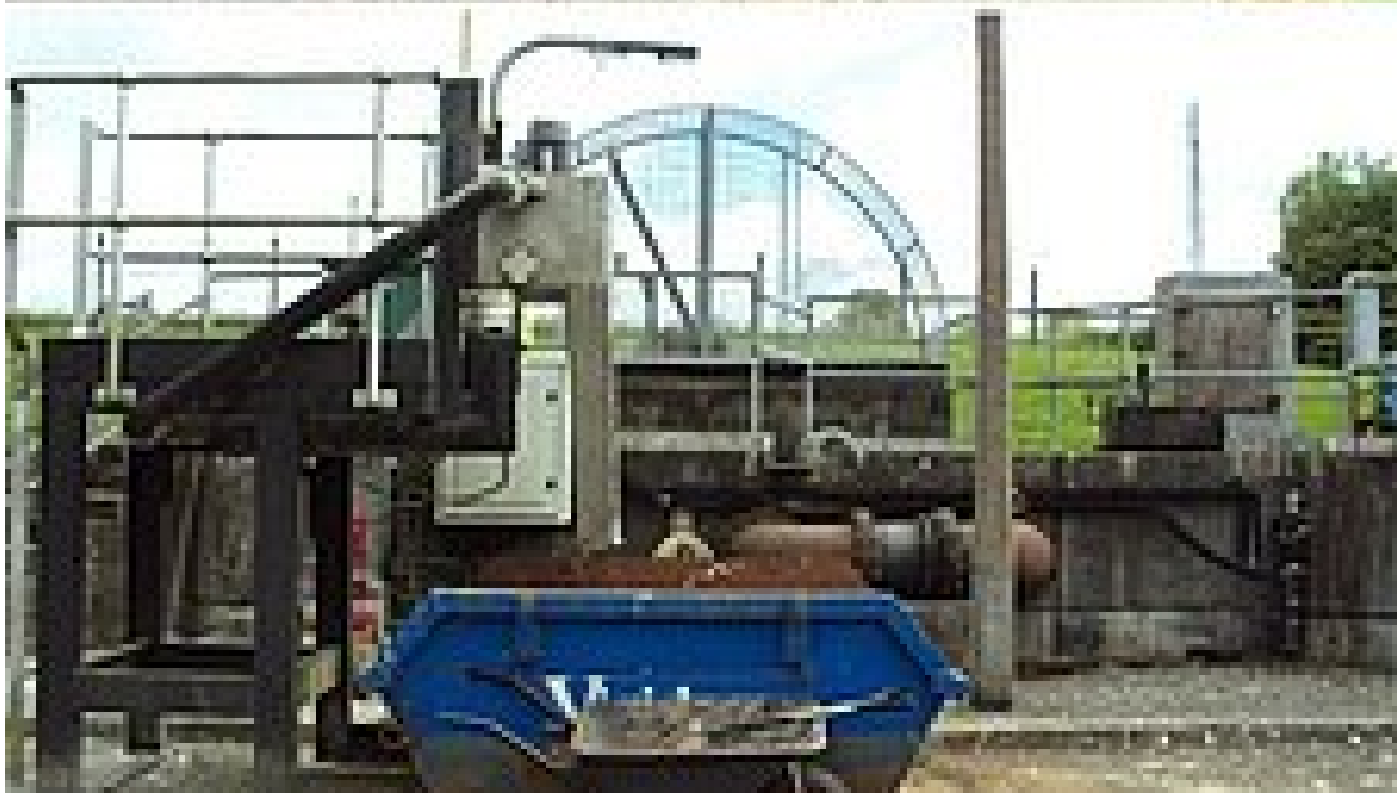
The old equipment installed was at the end of its asset life and constantly failing

Installed on site was an old 20mm bar screen discharging into a launder feeding a macerator and licep unit. All the equipment installed were at the end of their asset life and were constantly failing. The inlet screen was also allowing rag to bypass it due to its age.
