Solution for Plugging Problems in Wisconsin, USA

The Village of Oostburg, WI was experiencing clogging problems throughout their wastewater treatment plant. The clogging was due to a malfunctioning comminutor of their influent pump station in their headworks structure. The existing grinder was often out of service and repairs were very costly. It was the desire of the City to upgrade the plant by installation of a fine screen.

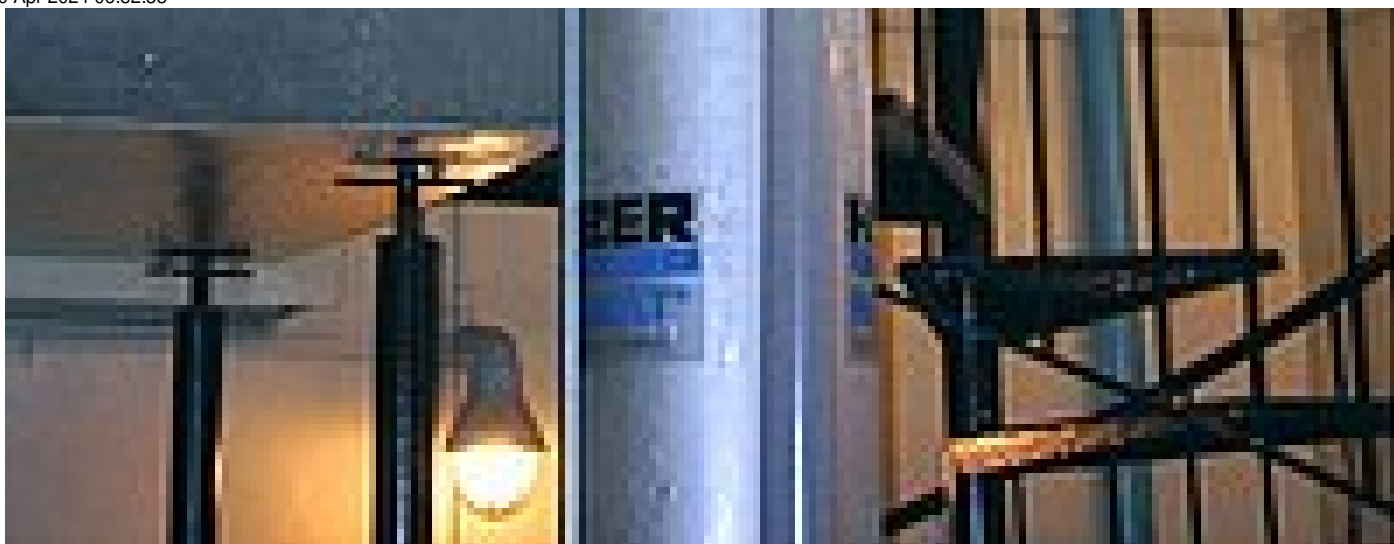
Vertical screenings transport tube of the RoK 4

HUBER TECHNOLOGY, offering the widest range of screening technologies worldwide, had the solution to solve this problem. The RoK 4 vertical drum screen could be installed in the very short channel and could lift the screenings to the desired height without any need to modify the building. It was the consultant's idea to place the screen basket in the same location as the grinder and lift the screenings vertically to the upper floor for disposal. The RoK 4 does not only screen the wastewater but also washes, transports, dewater, compacts and deposits the screenings into an endless plastic bag. All this is accomplished on one square meter of floor space.

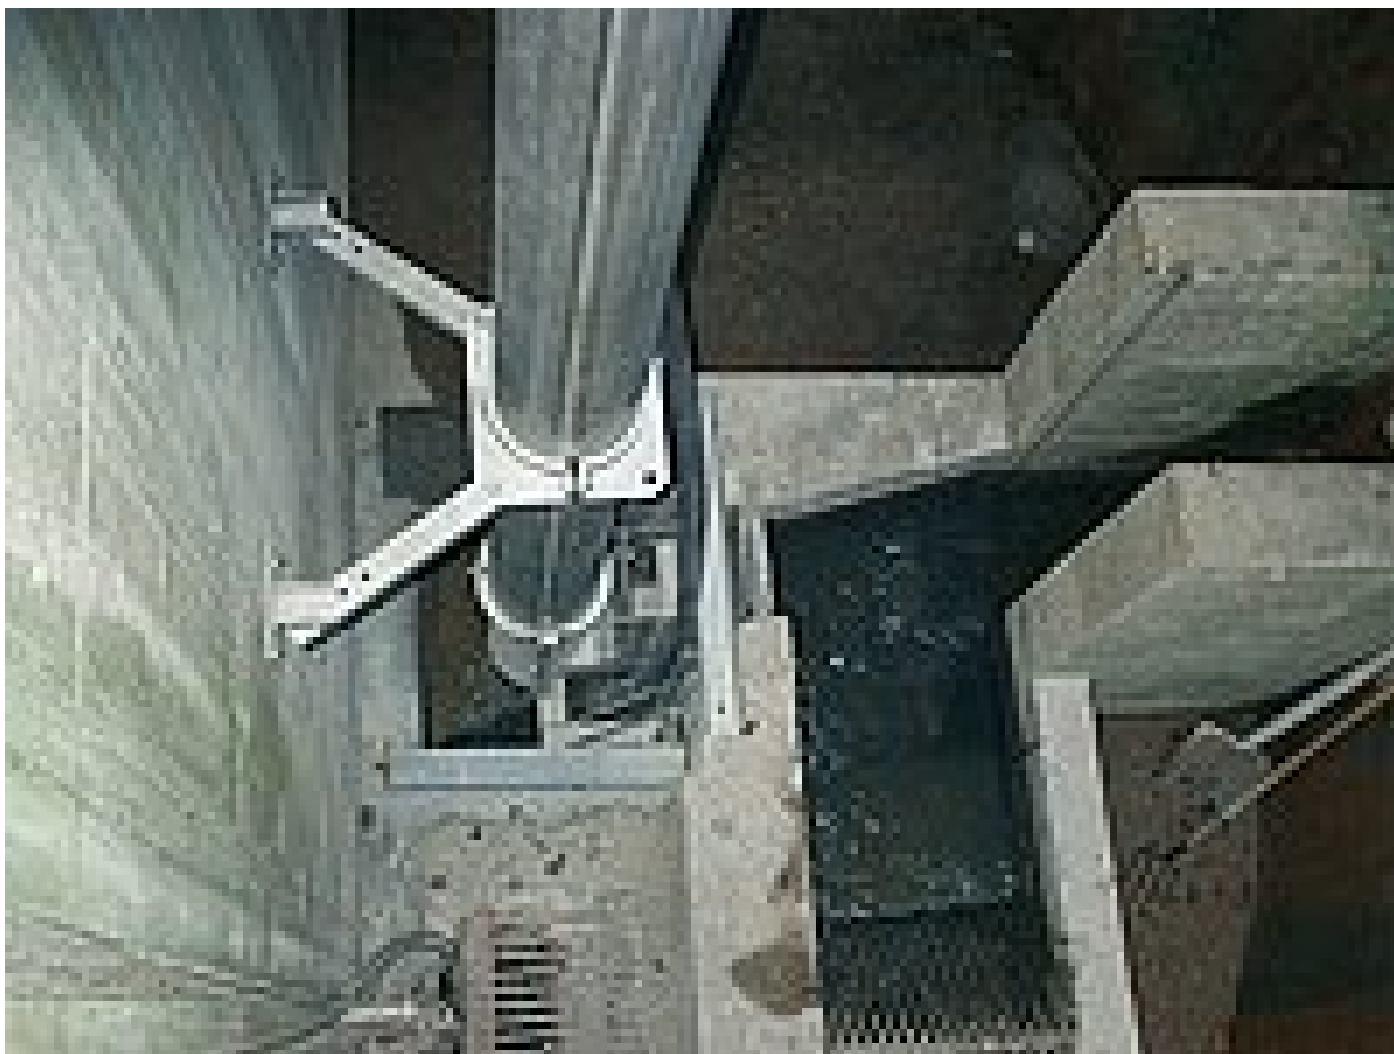
Lower section of the RoK 4 with screen basket and IRGA for screenings washing

We modified the standard machine's piped inlet to match the inlet-channel's rectangular cross section. We accomplished this by removing the pipe inlet and modifying the inlet box with angles that could be attached to the channel. The design team working with HUBER engineers came up with a clean, safe and cost effective solution. The plant has not experienced any clogging problems since the screen was brought online. The Village of Oostburg is very satisfied with the performance of the new screen.
